Volume 14 | June 2012 | Number

SGS INTRON
BULLETIN

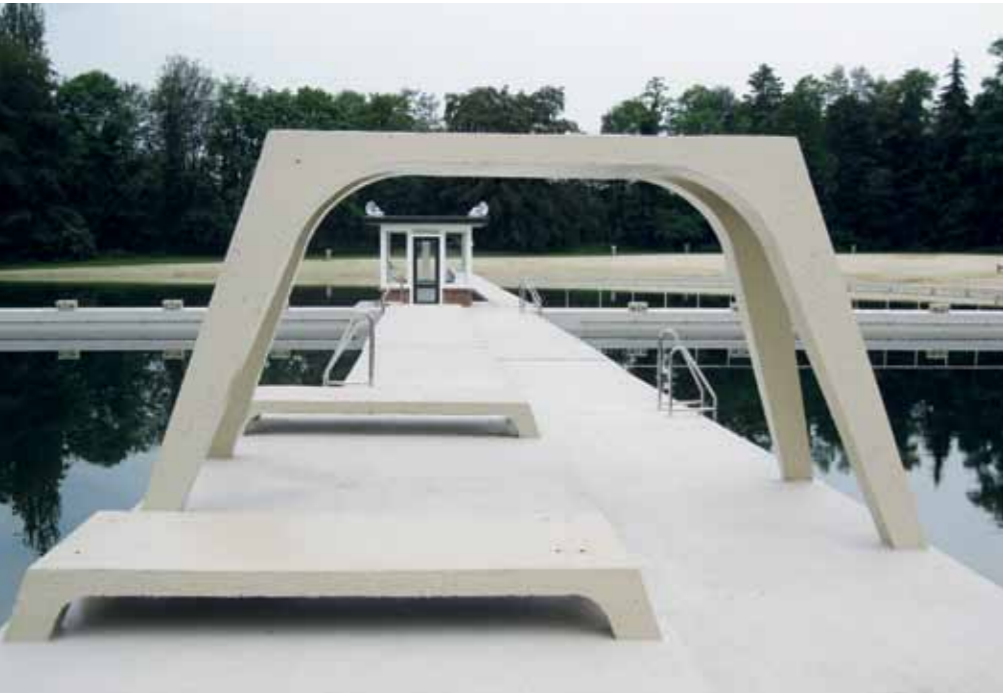
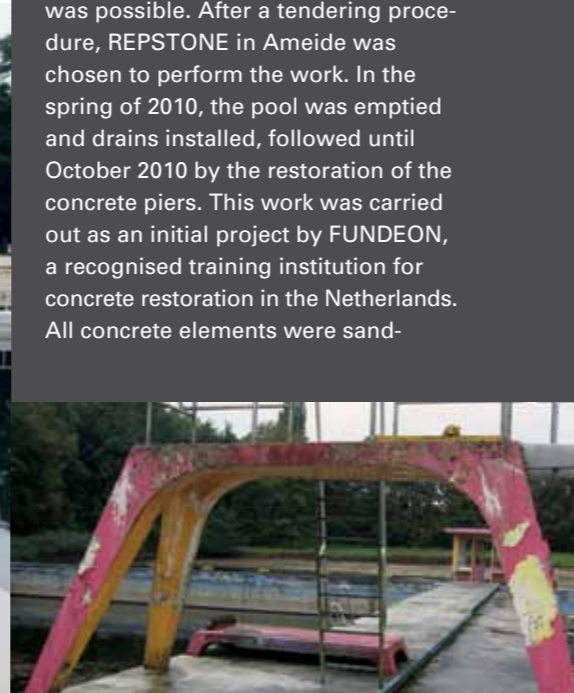
The result is impressive. The restored complex has been made beautiful again. The piers and the characteristic starting blocks and diving towers have been restored (see photo). Since summer 2011, the pool has again been used for swimming, just like in the good old days!

One part of the restoration was the repair of the concrete piers and diving tower (see photo). In consultation with the National Heritage Board (RCE), SGS INTRON carried out extensive investigation of the damage mechanisms in the concrete structures at the lido. They also provided repair advice that served as a starting point for the restoration call for tenders.

The investigation consisted of a visual inspection, on-site measurements and the taking of drill cores and dust. Different kinds of cracks were discovered, caused by thermal dilation, mechanical loads, settling and expansion reactions. The expansion reactions were potentially dangerous ASR, a possible combination of sulphate attack and frost damage. This damage was caused by long-term moisture transport through locally porous concrete. A considerable portion of the concrete structures was seriously degraded. The expansion reactions were still occurring. There was widespread surface damage attributable to a concrete layer that was of insufficient thickness and quality locally.

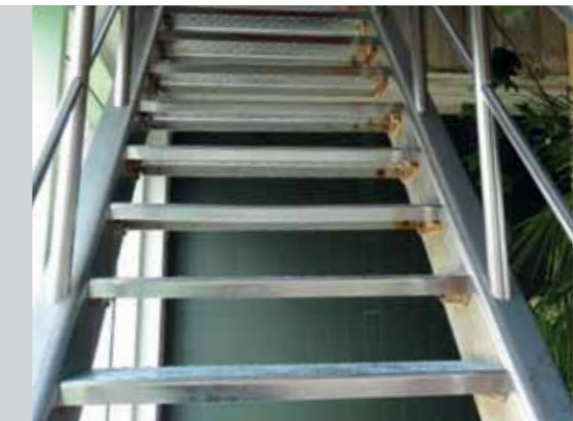
should ensure that the owners of covered swimming pools carry out regular inspections of (suspended) steel structures and fastening systems. The owner must therefore ensure that no safety risk is present or ongoing. Owners of covered swimming pools have primary responsibility for the regular inspection and replacement of (suspended) steel structures and fastening systems. SGS INTRON experts carry out these inspections according to the NACE Benelux MIS-1203-2012 method. This method involves a risk analysis of the (suspended) steel structures and fastening systems, and specifies measures to be taken immediately and those for the longer term. In this way, risk areas are mapped, enabling specific maintenance to be undertaken.

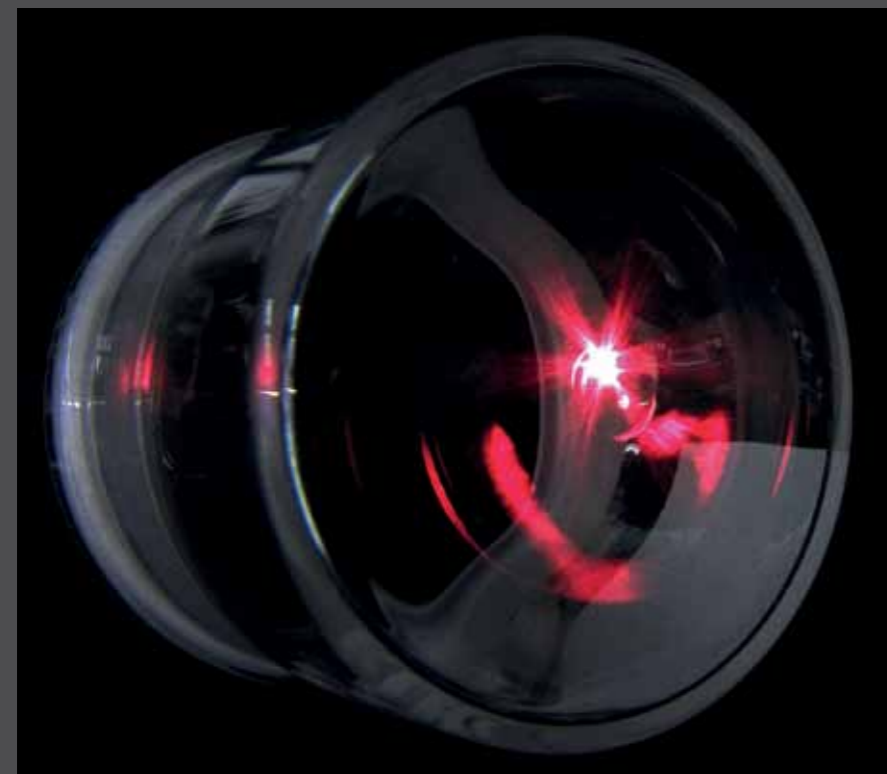
The lab is often asked this question and when we investigate, the use of ATR/FTIR can often reveal interesting information and give us an idea of the composition of the unknown material. The results of the measurements relate to the overall composition. Infrared spectrometry is not suitable for identifying trace elements. Generally speaking, substances in low concentrations, that is below a few percent, are difficult to detect. The measurement results are qualitative, meaning that we identify the type of sample without measuring the concentrations of the substances present. Unfortunately, there are also a few substances such as metallic compounds and carbon which do not absorb infrared radiation, and the technique is not suitable for them.

ATR/FTIR analysis only needs a small grain of material or a drop of liquid, and that is handy where very little sample material is available. We often use this technique in combination with microscopy. Under the microscope, we can select the parts of the sample that are interesting for the analysis and if necessary, we can even irradiate microscopically small particles by connecting the ATR/FTIR directly to the microscope.

Infrared spectrometry is used successfully to identify coating types or for determining the fingerprint of a desired coating system. This fingerprint allows us easily to establish whether the product used meets the set criteria. For restoration work, it can be important to determine the type of binder used or, for example, whether lime or gypsum or a mixture of both has been used, such as when sticky spots are found on the floor of a parking station, or white spots on a facade. ATR/FTIR shows the composition clearly.

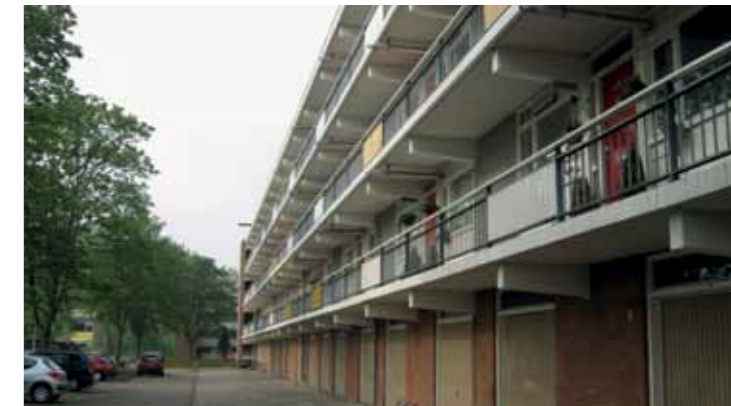
Gallery flat overview.

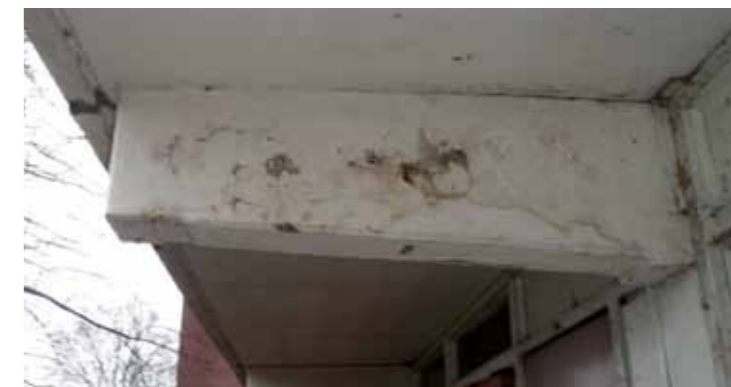
Brackets in which cracks were found during the visual inspection.

In his presentation "Five steps to a trustworthy galley flat" Martin Jonker explained how potential problems are identified via a risk analysis and how they can be handled. His colleague Maarten Swinkels explained what damage can occur and how this can be recognised. To conclude, Theodoor Gijsbers detailed the possibilities in the area of non-destructive testing: "SGS INTRON has a whole range of advanced techniques such as radar and eddy current tests designed to investigate concrete and reinforcement without damaging the structure. This is a strong point as - combined with minimal and highly selective destructive testing - we can reliably map the entire structure."

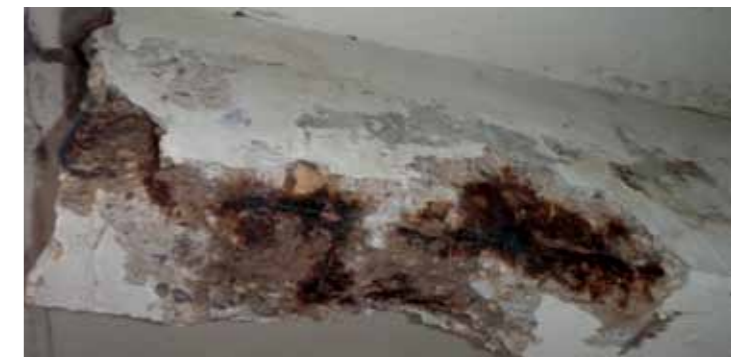
Serious reinforcing corrosion (initial chloride) found by destructive testing.
